Anomaly of XIS2

T.Dotani (ISAS/JAXA) and the XIS team

September 29, 2007

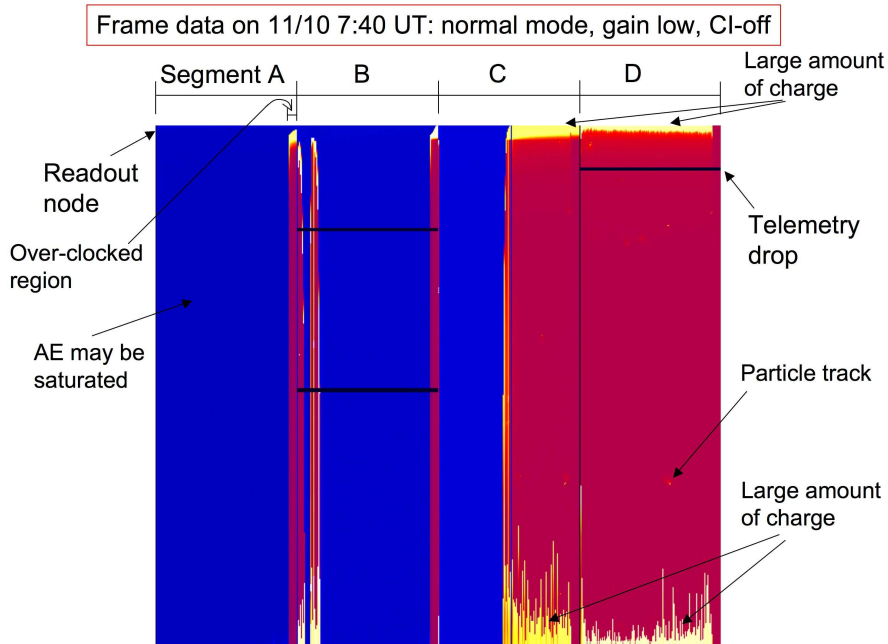
Because of the sudden increase of "pixel number" at 1:03:22, it is clear that a large amount of charge overflowed in the CCD. This is also clear from the increase of "HOC"; the large amount of charge overflowed even in the overclocked pixels. The "pixel number" decreased soon. We suspect this is because the analogue electronics (AE) was saturated with the large amount of charge.

We show below an image of the frame mode data taken on Nov. 10. The blue region in segments A, B and a half of C indicates that the AE was saturated due to the large amount of charge exceeding the dynamic range of AE. The red region, segments D and a half of C, indicates that the region worked OK; particle tracks were detected.

When we changed the clock voltages in the imaging region, amount of the leaked charge was observed to change. This indicates likely short between the electrodes and the buried channel. Possible mechanisms to cause the short include micro-meteoroid impact on the CCD, as seen on XMM-Newton (5 times) and Swift (once). Although there is no

direct evidence to indicate the micro-meteoroid impact, the phenomenon observed in XIS2 is not very different from that expected from the micro-meteoroid impact. Low-earth orbit and the low-grazing-angle mirrors of Suzaku may have enhanced the probability of the micro-meteoroid impact.

Because it is difficult to recover XIS2, we simple stop operating the sensor. It is unlikely to resume the operation of XIS2 in future.
